**HUMER KWER HEALTH CENTER
SULAYMANIYAH, IRAQ**

SUSTAINMENT ASSESSMENT

**SIGIR PA-09-186
APRIL 20, 2010**

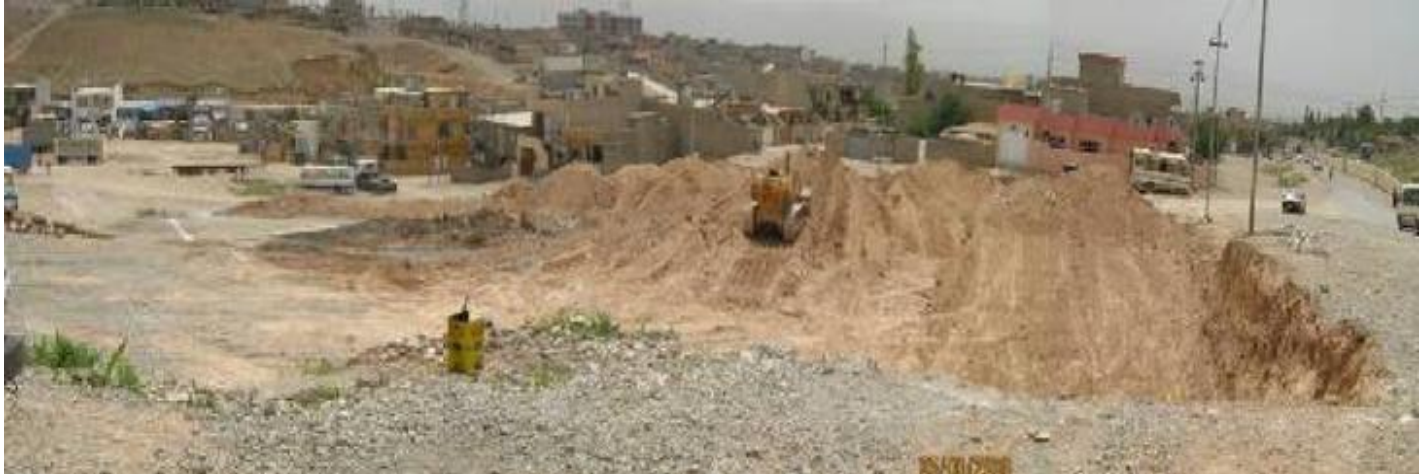
Site Photo 1. Initial excavation of project site

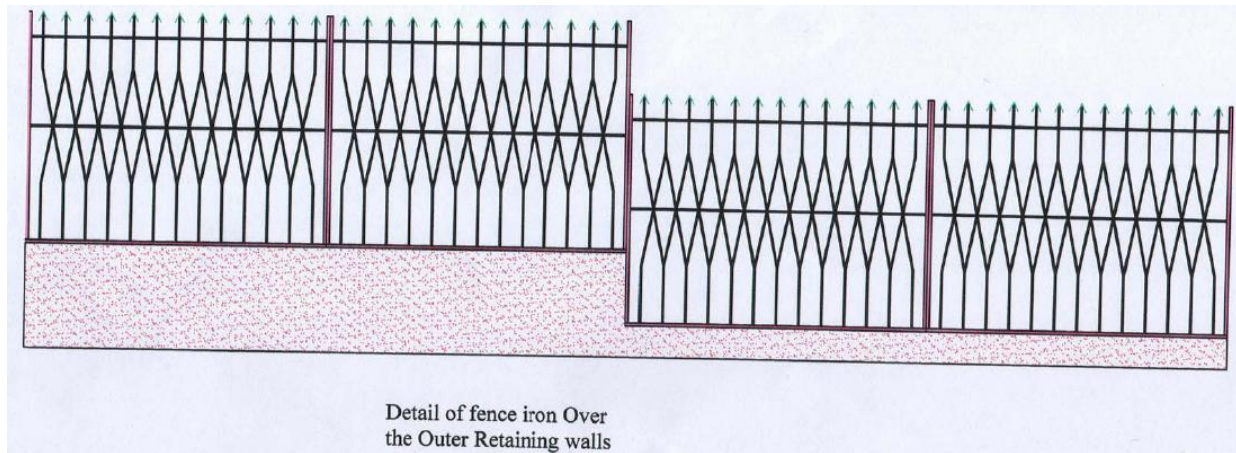
The perimeter security wall details provided with the conceptual design drawings included details for the concrete masonry unit⁴ (CMU) wall, foundation, and reinforcement for the gates and is identical on the contractor's drawings. In several areas the need for a retaining wall precludes the construction of a CMU security wall. In these areas, the contractor proposed a steel fence mounted to the top of the retaining wall (Figure 2).

**Figure 2. Steel fence secured to retaining wall
(Courtesy of GRN)**

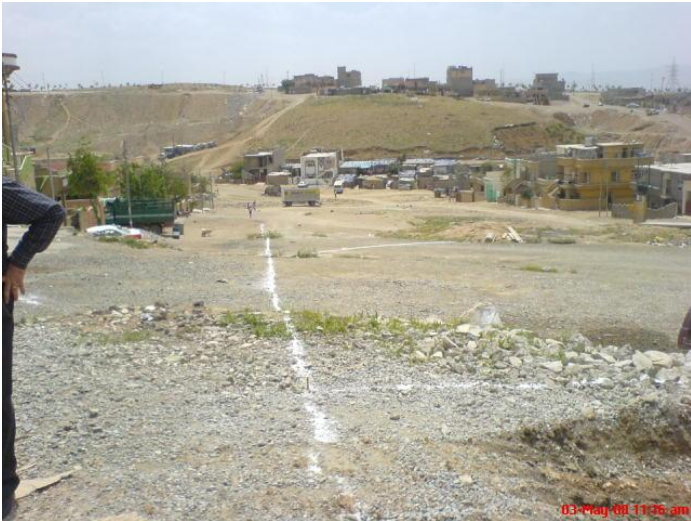
Before new construction could begin, the contractor cleared and excavated the project area. Site Photo 2 shows the obstructed future site of the Humer Kwer Health Center, with debris that required removal, and Site Photo 3 shows the site after the contractor excavated and cleared the area.

Site Photo 2. Site layout before modification (Courtesy of GRN) Site Photo 3. Site after excavation (Courtesy of GRN)

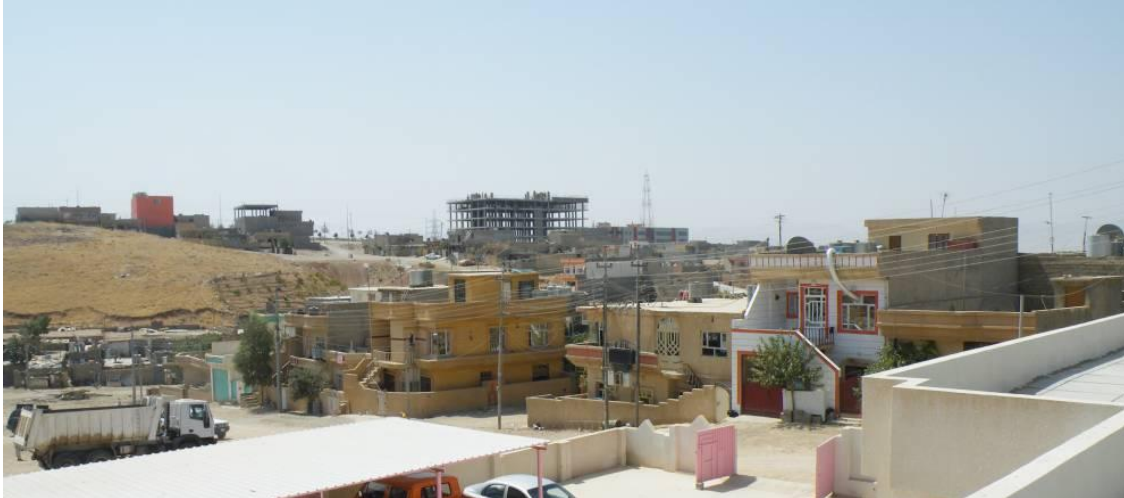
The Humer Kwer Health Center project is located in a recently developed section of Sulaymaniyah. The general topography of the area is moderately steep with the majority of new residential development occurring on the hillsides surrounding the city center (Site Photo 4). Public utilities were available at the project site and included potable water, sanitary sewer, and electricity.

Site Photo 4. Surrounding residential development

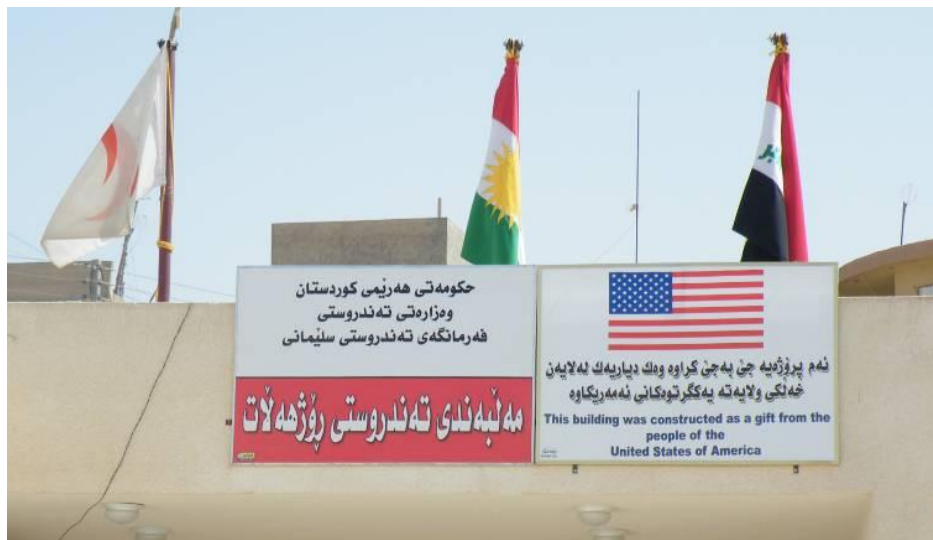
The facility contained three entry points, a primary entry point to the upper level with a secondary entry at the generator's location, and an auxiliary entry point at the lower level. The upper level entry is the primary entrance for patients and is identified with signs, and included a sign indicating the U.S. government's involvement with the project (Site Photo 6).

Site Photo 6. Entrance sign

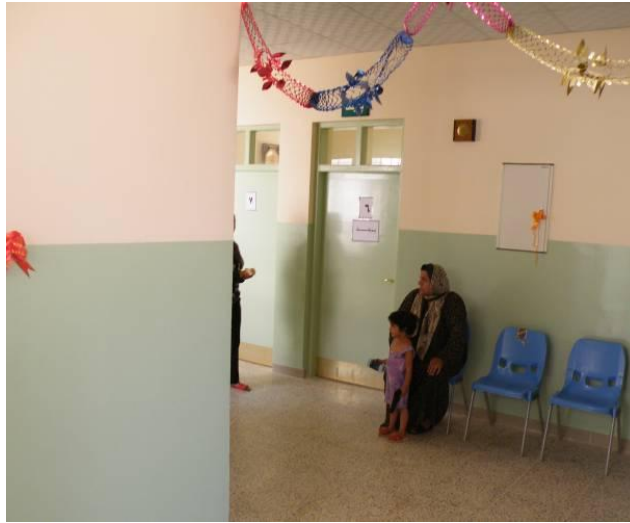
Upon entry to the health center is a small waiting area (Site Photo 7) and a registration window for incoming patients. The waiting area was furnished with chairs, which were

Site Photo 7. Patient waiting area

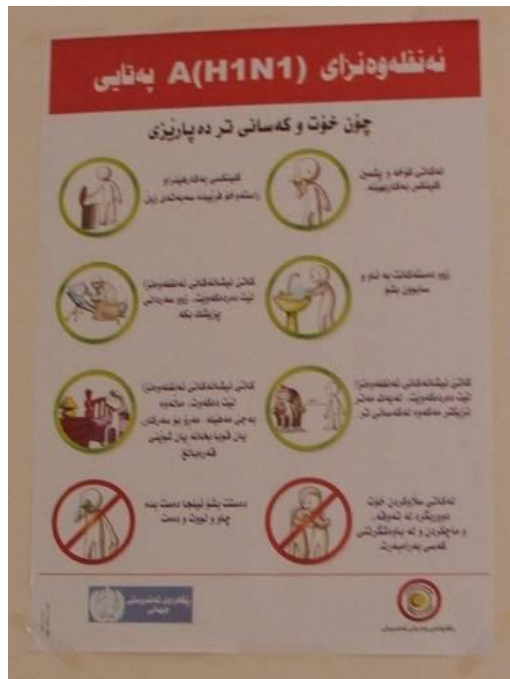
Educational posters were placed throughout the facility to promote awareness of public health issues (Site Photo 8).

Site Photo 8. Health education poster in Humer Kwer Health Center

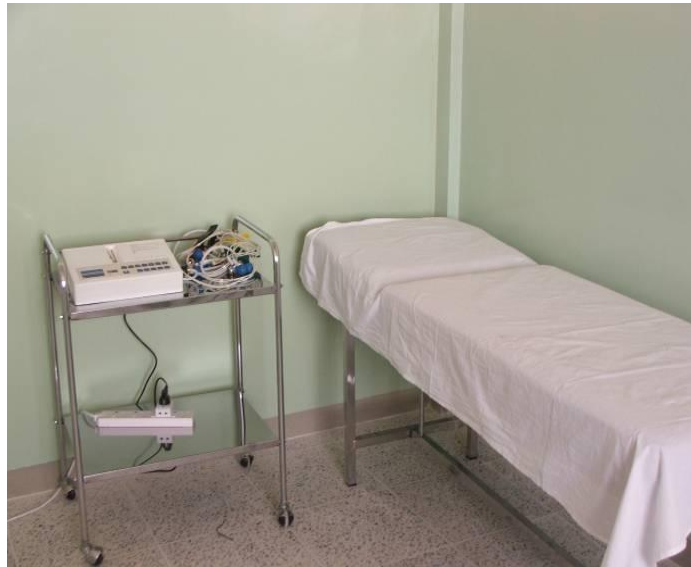
Patient exam rooms are located on the upper level of the facility (Site Photo 9). The contractor provided some furniture for the exam rooms and the Ministry of Health provided the medical equipment.

Site Photo 9. Patient exam room

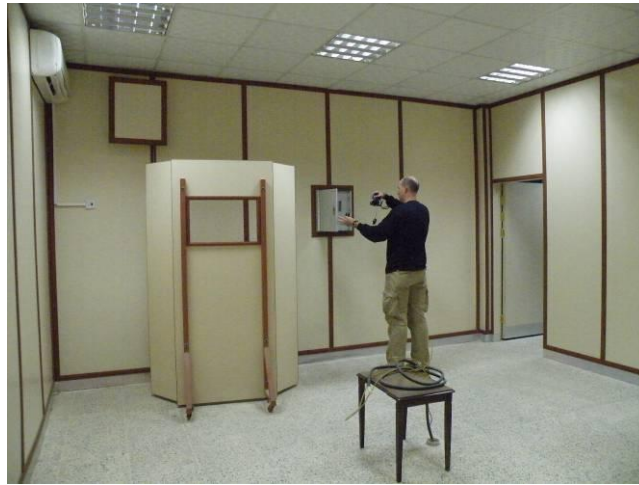
The diagnostic facilities and pharmacy are located on the lower level. The diagnostic facilities included an X-ray room, darkroom, and medical laboratory. The X-ray room appeared finished, but was lacking X-ray equipment. The local national project engineer stated that the X-ray equipment was awaiting transfer to the health center. The contractor installed a moveable barrier to protect the X-ray technician and extended the electrical line through the floor to be connected to the X-ray equipment (Site Photo 14). The pharmacy appeared secure, stocked, and able to dispense medication. The supplies were neatly organized on shelves.

Site Photo 14. X-ray room
